# *Pepco Community Bulletin*

**Feeder 15197 - Serving the Crestwood and Petworth Communities**

**Issue 2 - March 2007**

## **Background Overview of Feeder 15197**

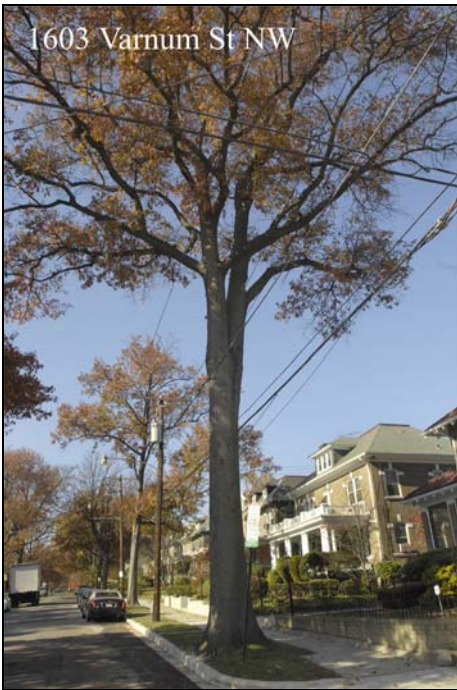
**LEFT** – The tree at 1603 Varnum Street, NW is an example of an apparent healthy tree that may actually have a compromised, or inadequate root support system and uproot in the future.

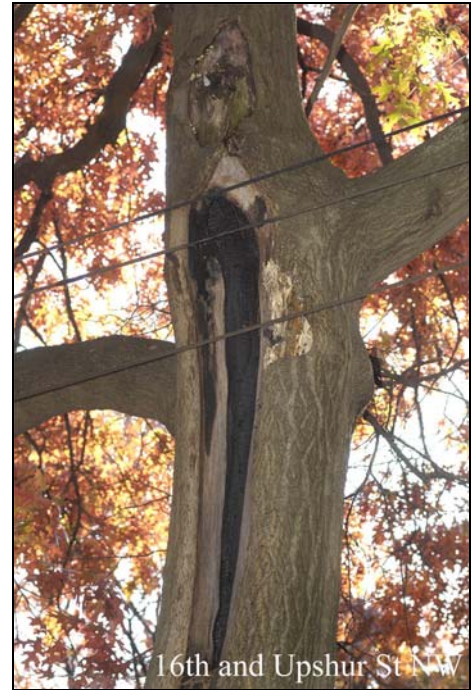
**RIGHT** – The tree in the 1600 block of Upshur Street, NW had evidence of repeated burning from direct contact with primary wires. The stress and heat on the wires caused a hazardous outage at least once when the energized wires broke and fell to the ground. The burning over a period of years also created a column of decay in the tree trunk creating an additional hazard.

The Urban Forestry Administration and Pepco cooperatively removed this tree in December of 2006.

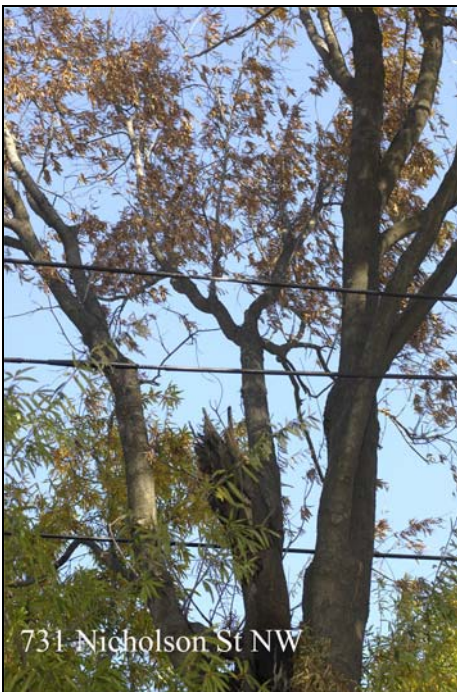
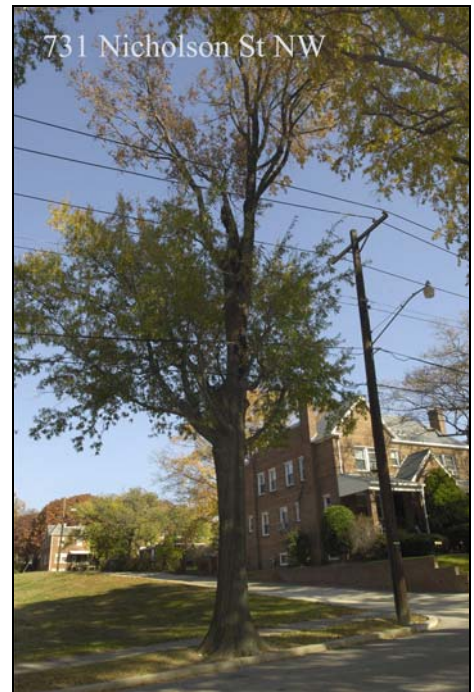
**LEFT & RIGHT** – This tree near 731 Nicholson Street, NW caused a power outage in August of 2006, affecting the whole feeder including residents in Crestwood. A large lead (branch) of the tree was in direct contact with a primary wire, causing slow periodic burning. Eventually the branch broke and landed across the phase wires causing an outage. The incident also effectively killed the tree by desiccating (drying) the cambium (veins or transport system) of the tree.

The Urban Forestry Administration and Pepco cooperatively removed this tree in December of 2006.
