Pepco Community Bulletin

Feeder 15197 - Serving the Crestwood and Petworth Communities

Issue 1 - February 2007

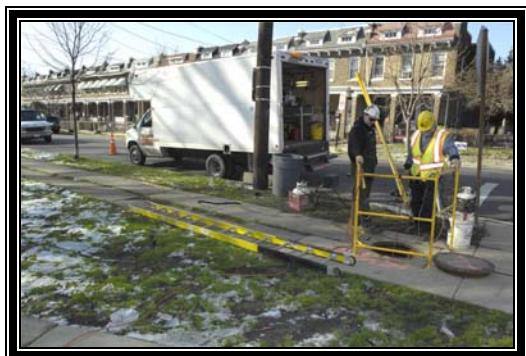
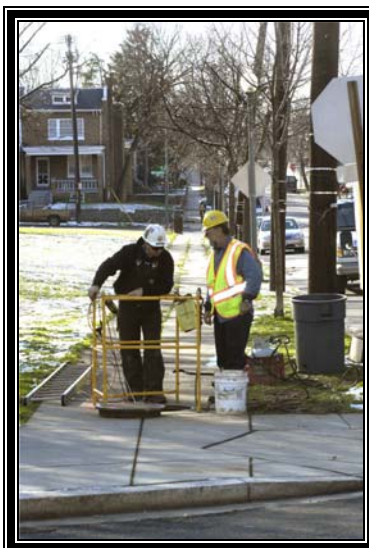
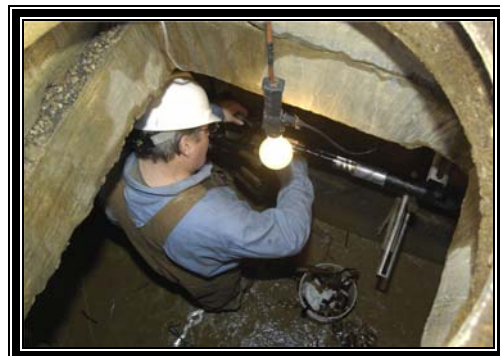
Below are 3 pictures of the crews replacing the underground cables along 9th Street between Gallatin and Hamilton Streets N.W.

Phase One of the planned improvements started the week of November 20, 2006, and was completed January 23, 2007 with the energizing of the newly installed 8,000 feet of underground cable. Some residents may have experienced brief outages due to this temporary transfer, but most customers were not expected to sustain any interruptions.

- Inspected equipment in 71 manholes along 9th Street, NW, and re-taped the connections and splices.
100% Completed
- Replaced approximately 8,000 feet of underground cable along 9th Street between Allison Street, NW and Nicholson Street, NW. Estimated completion was February 2007 – actual completion was January 23, 2007.
100% Completed
